INTEGRATED ASSESSMENT (IA) REPORT

**ASARCO
Columbus, Franklin County, Ohio
U.S. EPA ID: OHD056743933**

OHIO ENVIRONMENTAL PROTECTION AGENCY

September, 1995

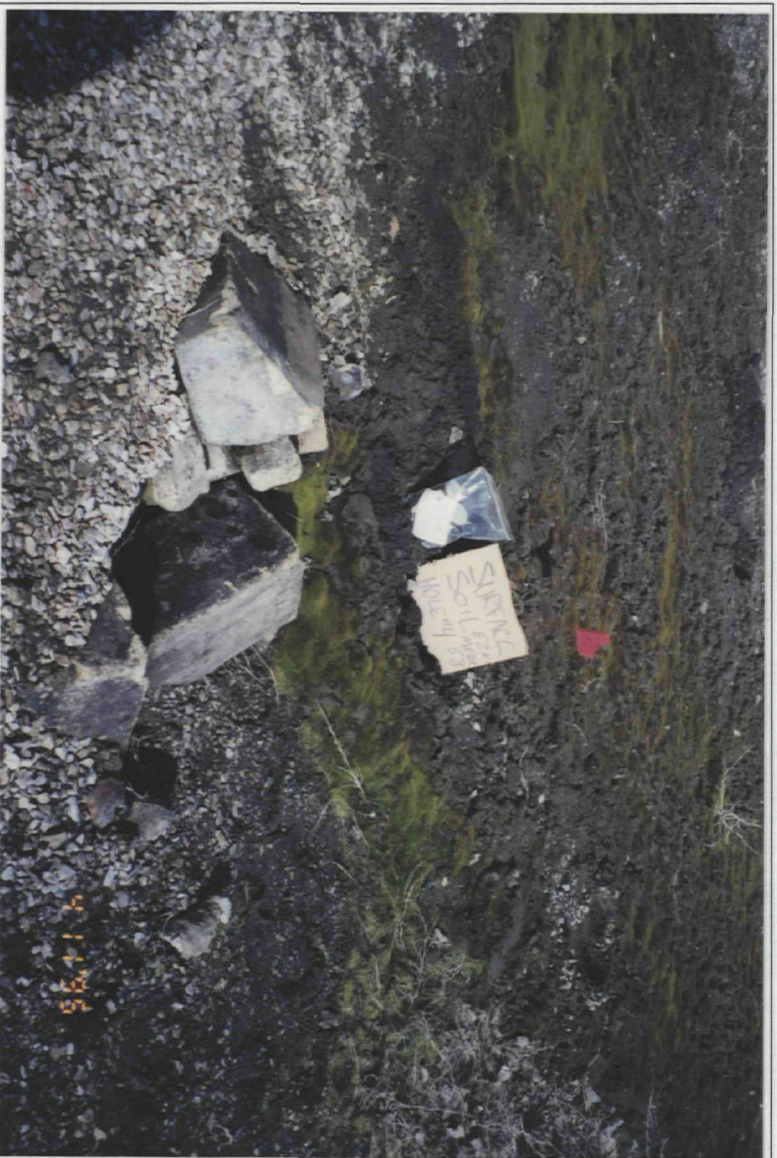
Photo No: 2

Description: A close up view of the above soil sample.

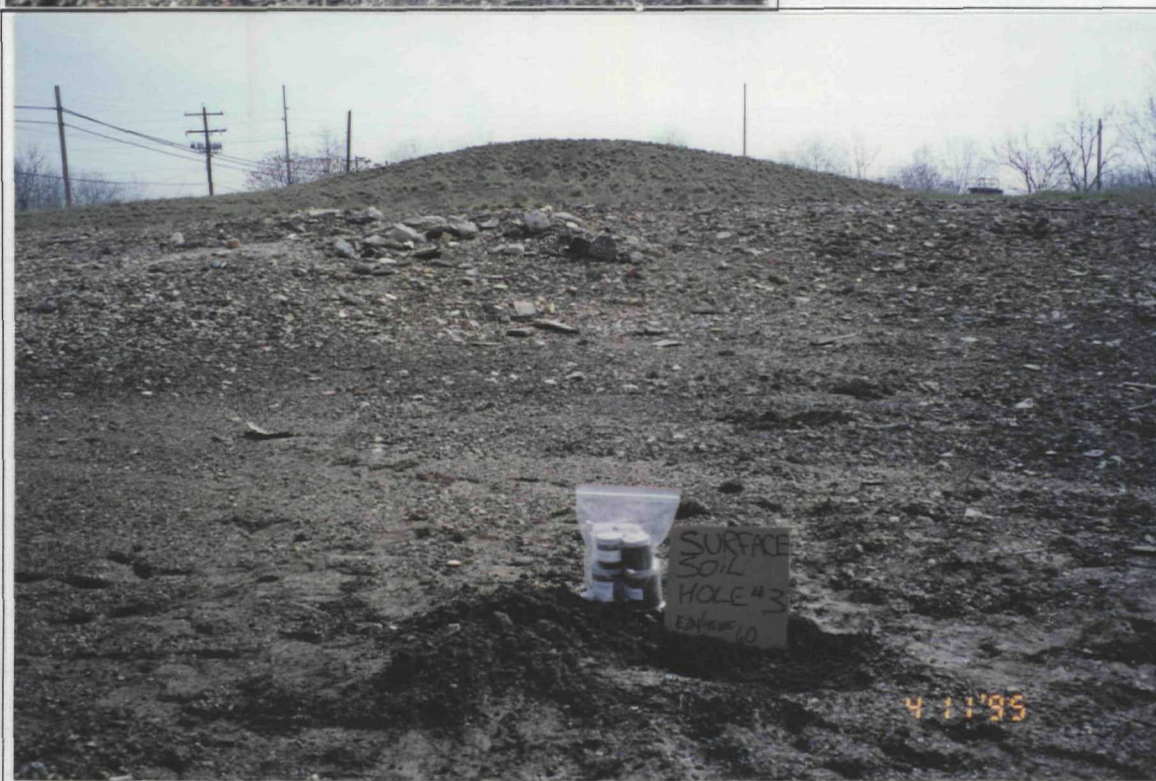
Photo No: 4
Sample No: SO-60
Date: April 11, 1995
Orientation: East
Description: Surface soil sample collected west of a large mound, south of Windsor Ave.

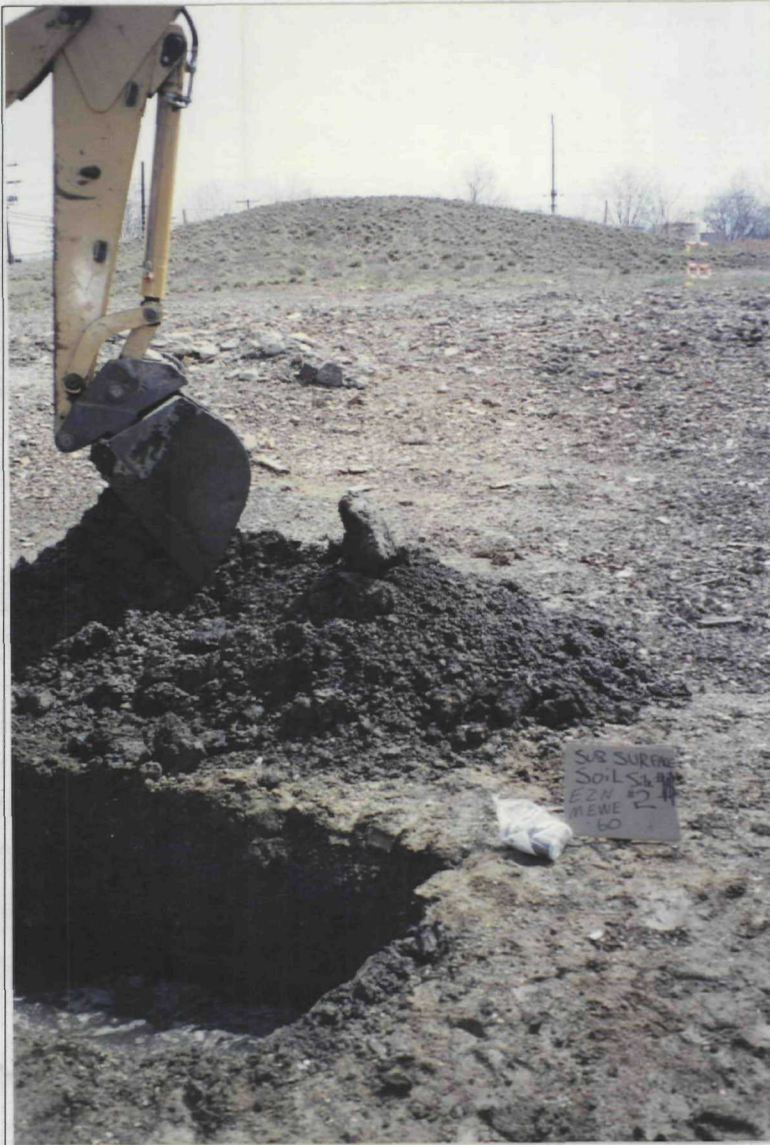
Photo No: 5

Description: The excavation by the backhoe for sample SO-86. Water collected in the hole immediately.

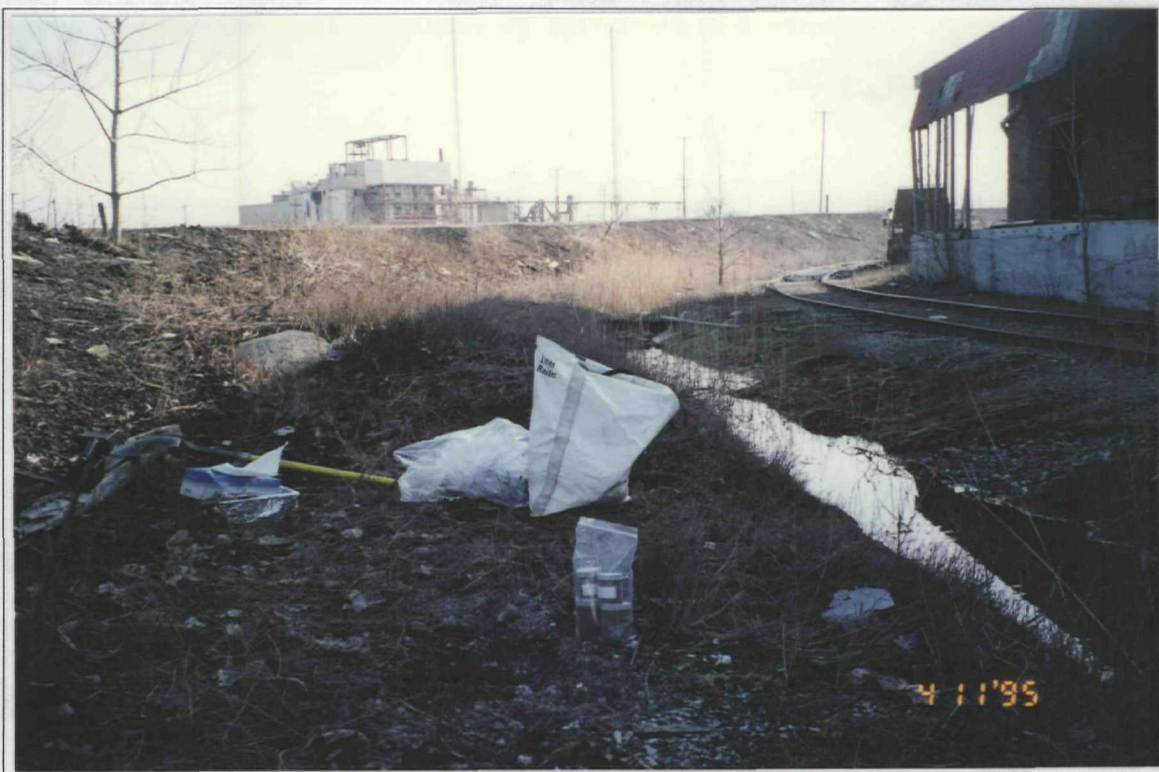
Photo No: 7

Zinc and cadmium were detected at concentrations greater than three times the background levels in all the soil samples. Zinc ranged from 2,060 parts per million (ppm) at SO-64 to 250,000 ppm at SO-65 (roaster building). Cadmium ranged from 84.8 ppm to 1,030 ppm, well above the background concentration of 1.4 ppm. Significant levels of mercury, lead, copper, arsenic and antimony also were detected in some on site soil samples. Mercury was detected as high as 0.75 ppm in SO-62, and elevated levels were detected in samples SO-58, SO-59, SO-60 & SO-65. The highest lead level detected was 695 ppm at roaster building, copper at 393 ppm at the maintenance building, and arsenic at 150 ppm at the oxide warehouse.

Description: A surface soil sample collected behind the oxide warehouse.

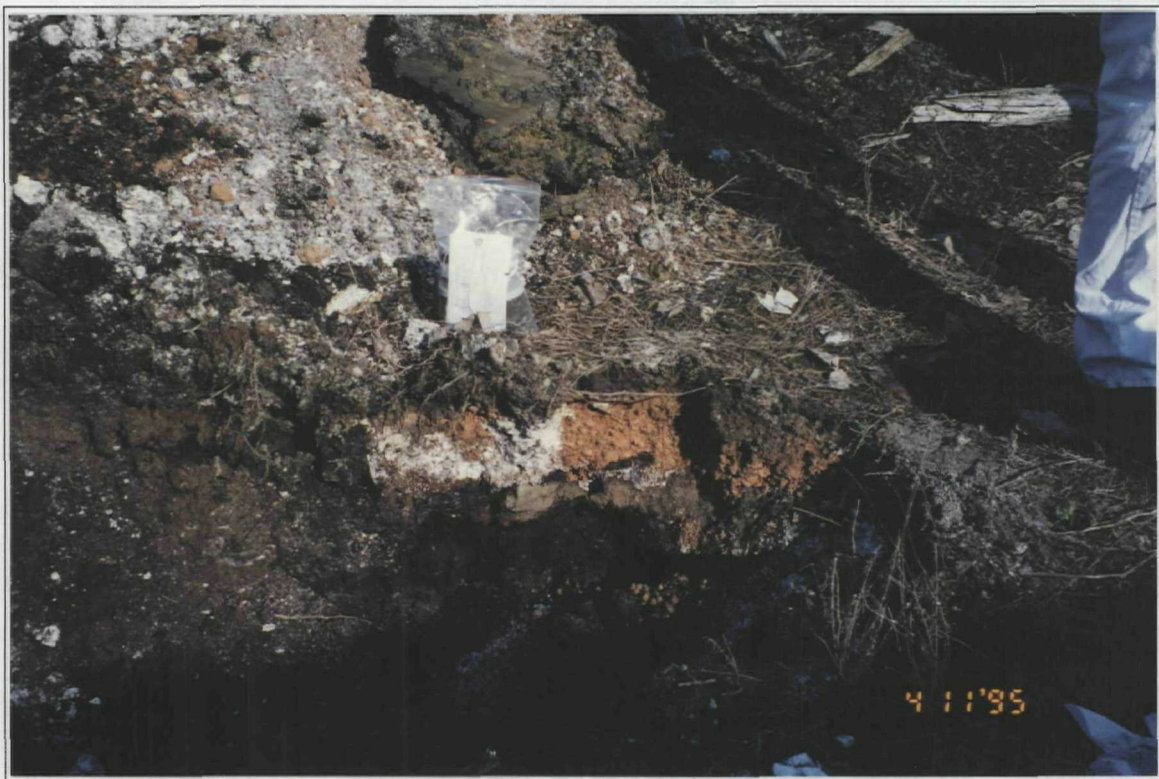
Photo No: 8

Description: A deeper sample collected at the same location behind the oxide warehouse.

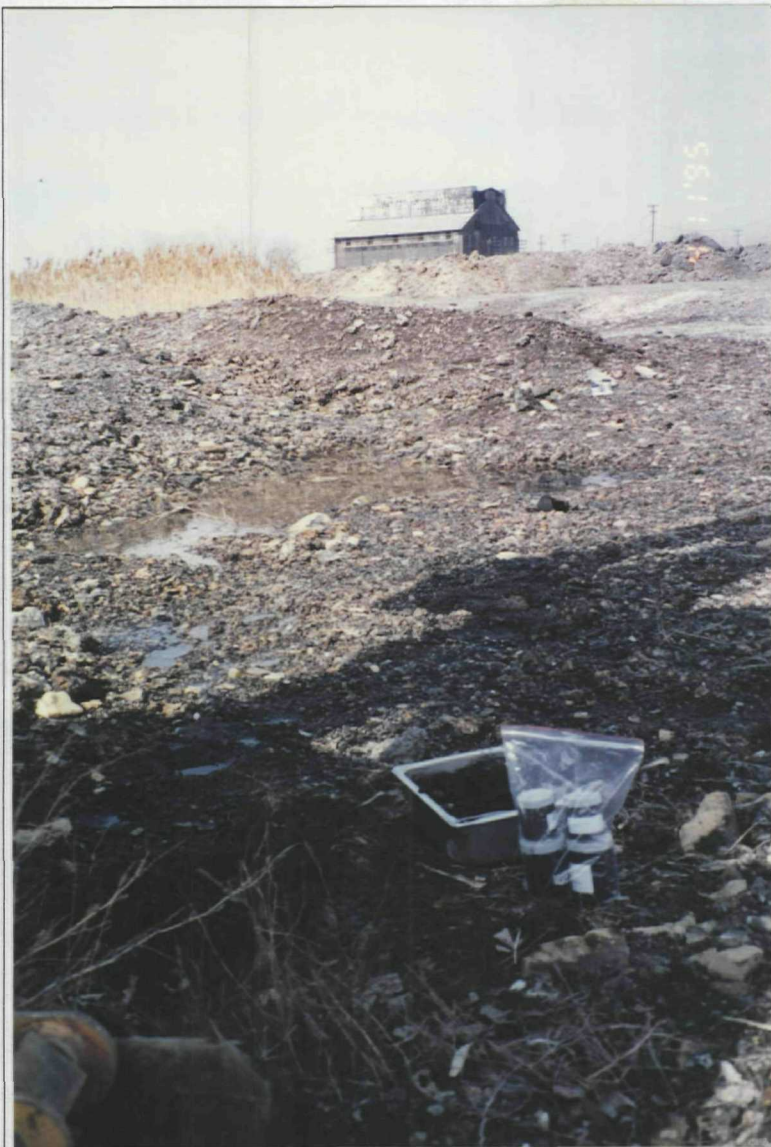
Photo No: 9
Sample No. SO-63
Date: April 11, 1995
Orientation: East
Description: The shallow soil sample location noted as south of the rail trestle.

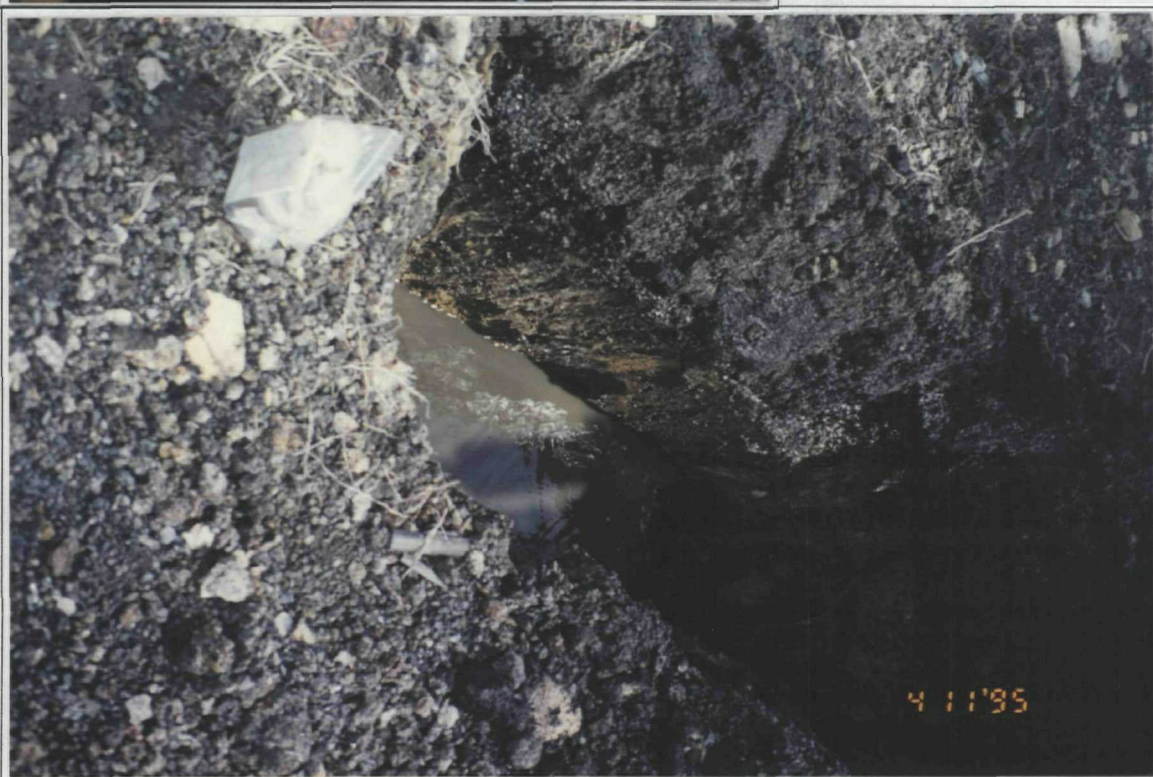
Photo No: 10
Sample No: SO-64
Date: April 11, 1995
Orientation: West
Description: The excavation by the backhoe for deep sample SO-64 also collected south of the rail trestle.

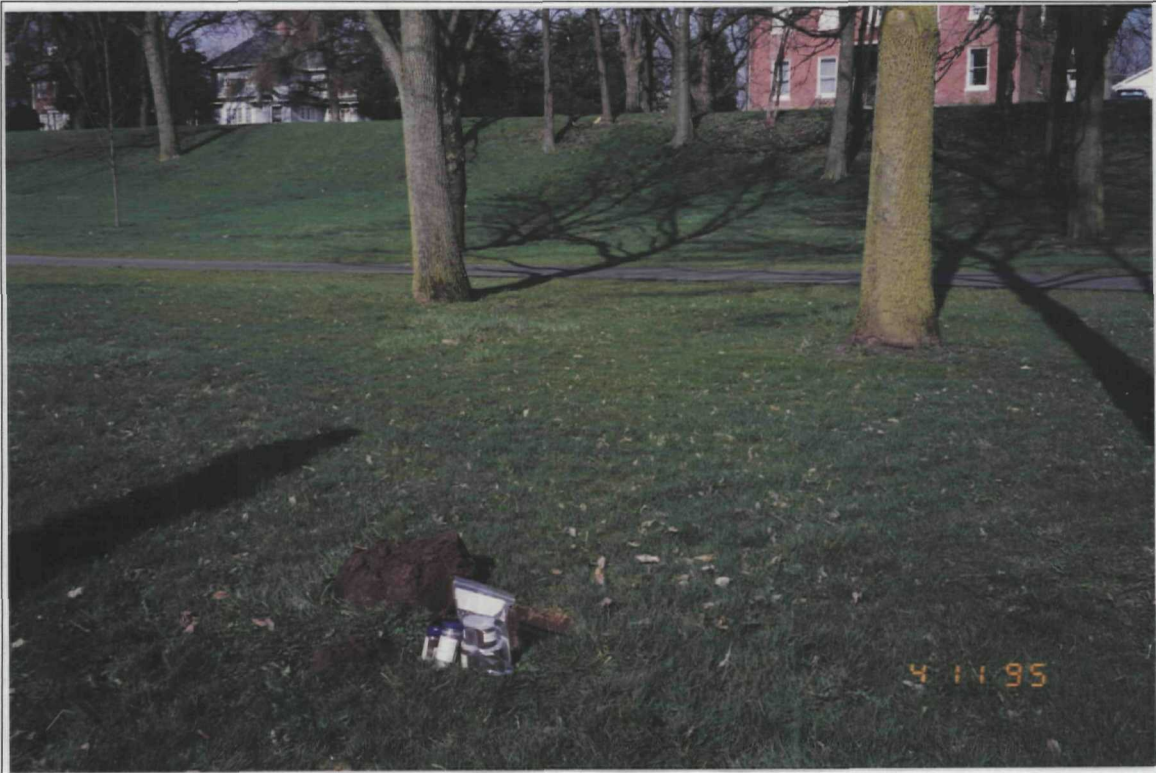
Photo No: 11

Description: The background soil sample collected at Nelson Park southeast of the site.

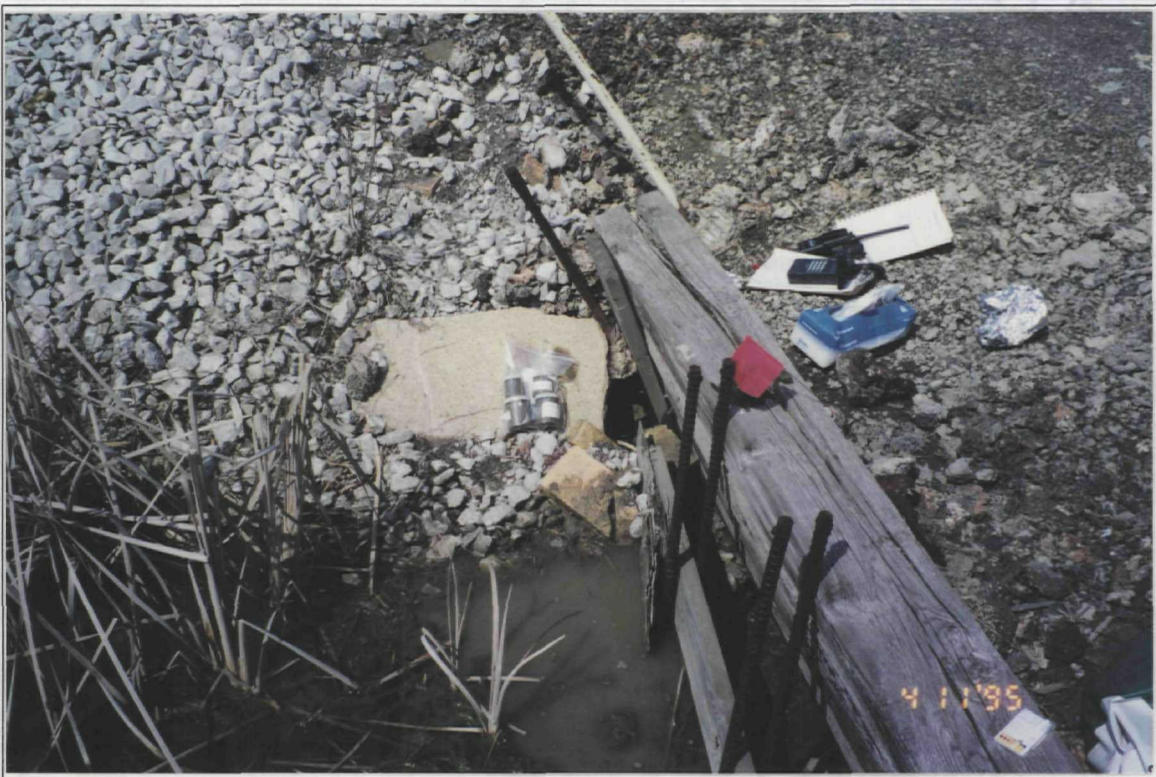
Photo No: 12

Description: The sediment sample collected in the Central Ditch.

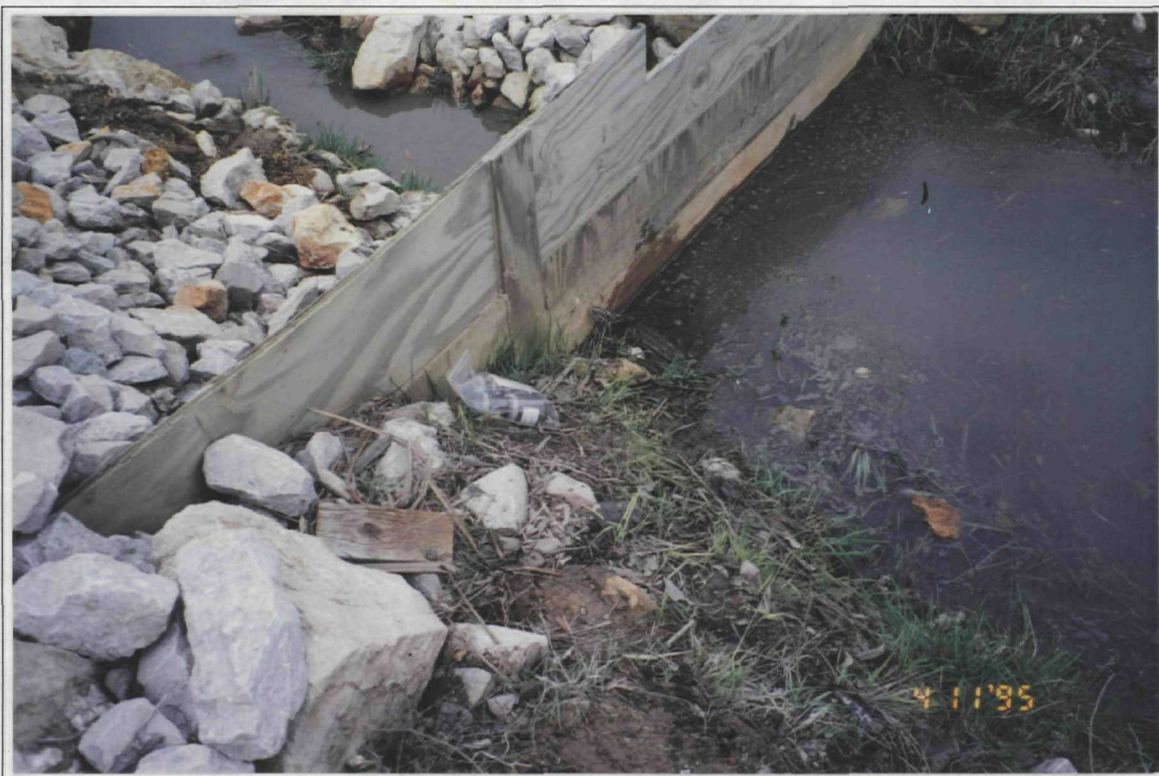
Photo No: 13

Description: The Central Ditch weir where a sediment and a surface water sample was collected.

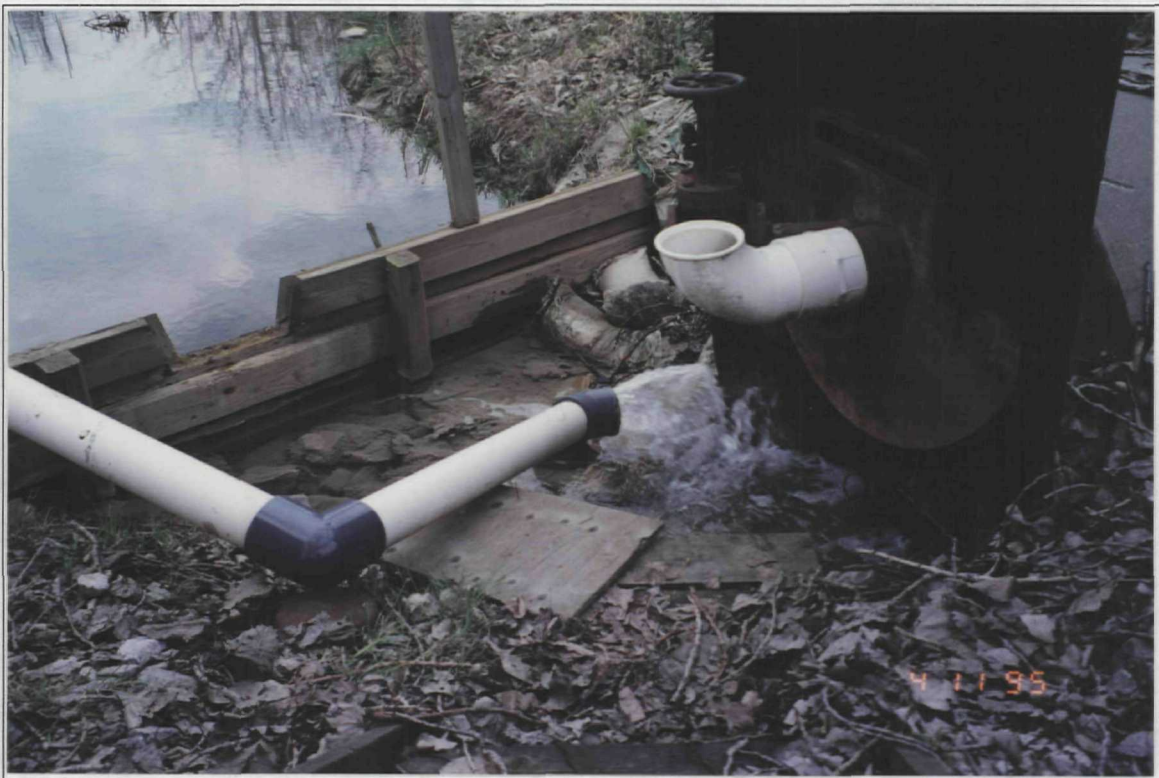
Photo No: 14

Description: The water treatment plant effluent being released to the Joyce Avenue outfall.

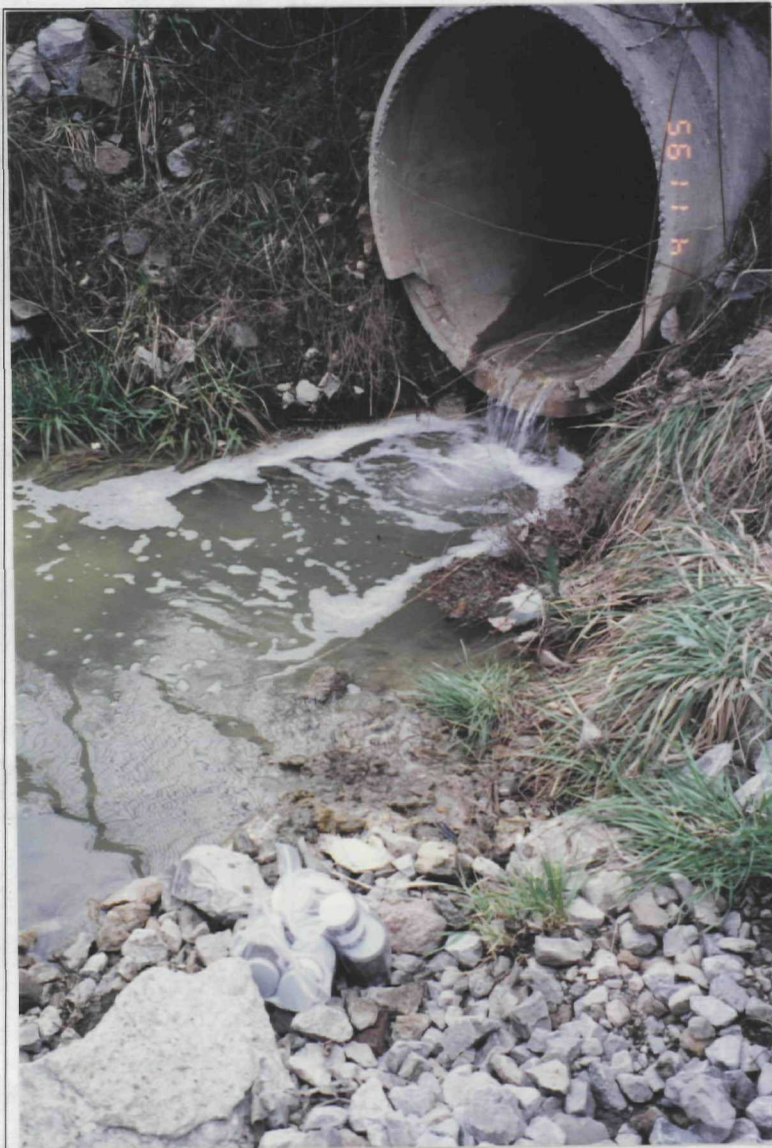
Photo No: 15
Sample No. SE-71, SE-72(dup)
Date: April 11, 1995
Orientation: Southwest
Description: The Joyce Avenue outfall between the site and Joyce Avenue where the sediment sample was collected.

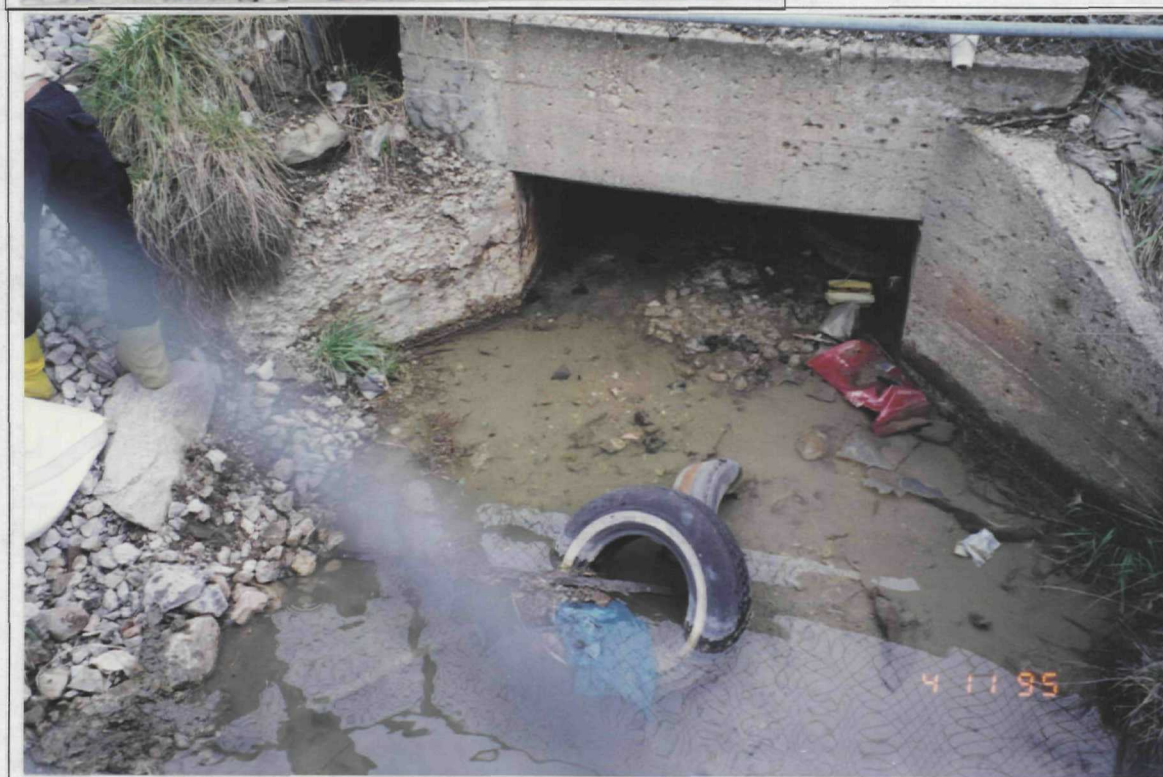
Photo No: 16
Sample No.: -
Date: April 11, 1995
Orientation: East
Description: Another view of the above sample location looking under Joyce Avenue.

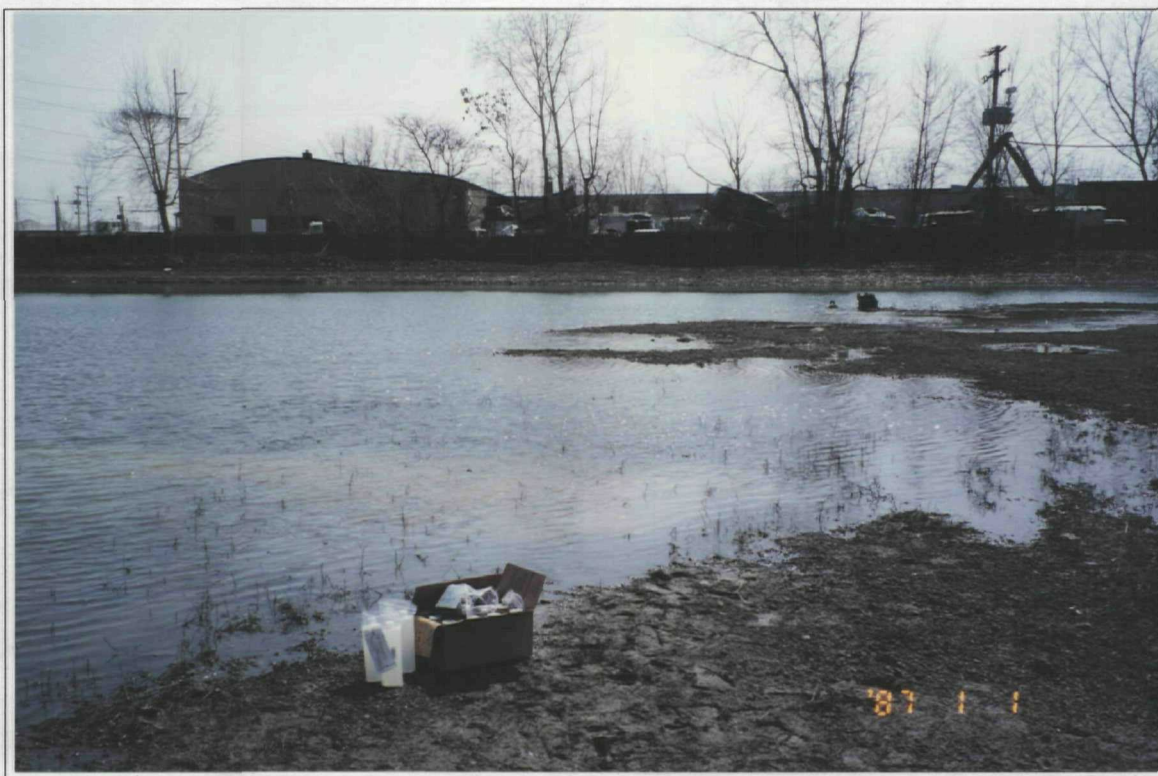
Photo No: 17

Description: The seasonally wet area on the southeast corner of the site.

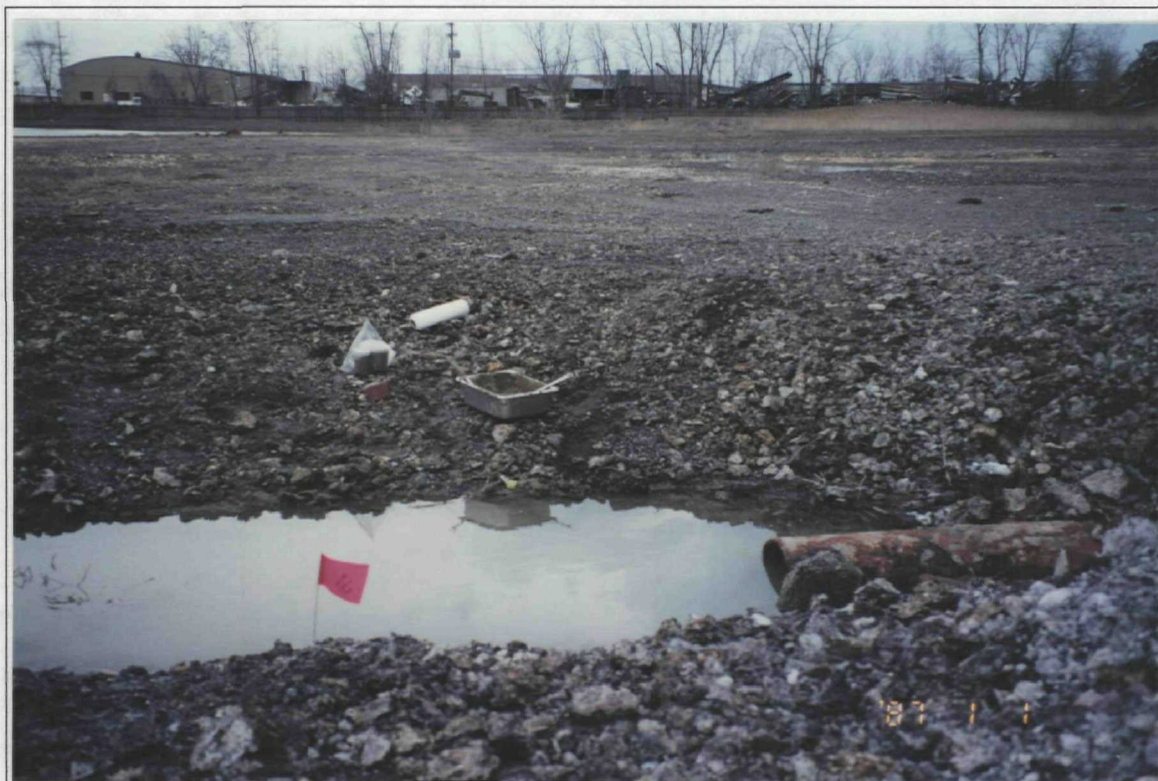
Photo No: 18

Elevated levels of zinc, cadmium, mercury, lead, and copper were detected in most of the on-site sediment samples. The highest levels of zinc were detected in SE-68 by the drain tile at 110,000 ppm and cadmium was detected at 444 ppm. Cadmium levels were highest at the Joyce Avenue outfall where the analyte was detected at 1,110 ppm, mercury was detected at 3.4 ppm, lead was detected at 397 ppm, and zinc was detected at 52,000 ppm. The highest mercury levels were found in the south ditch at 11 ppm. The sediment samples collected in Alum Creek had only a slight elevation in cadmium at 4.1 ppm in SE-74 and 2.4 ppm in SE-73.

Description: The sediment sample collected at the drain tile.

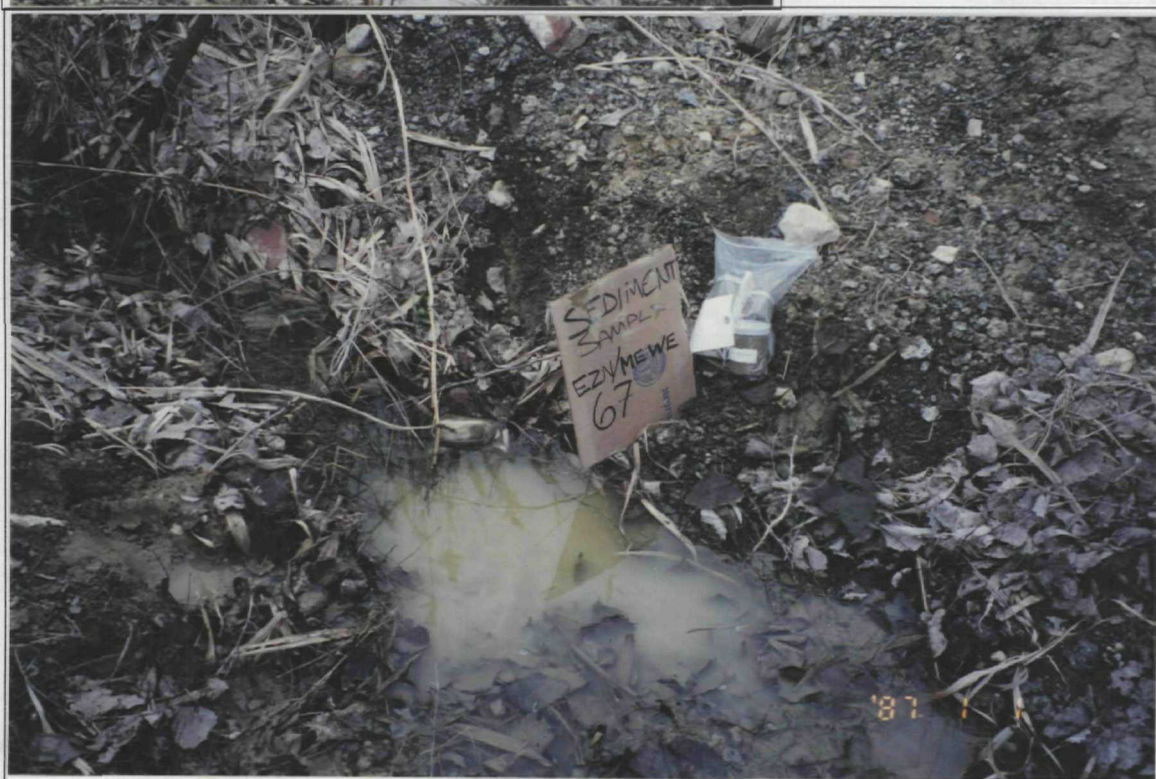
Photo No: 20
Sample No: SE-67
Date: April 11, 1995
Orientation: -
Description: The Baghouse Pond sediment sample.

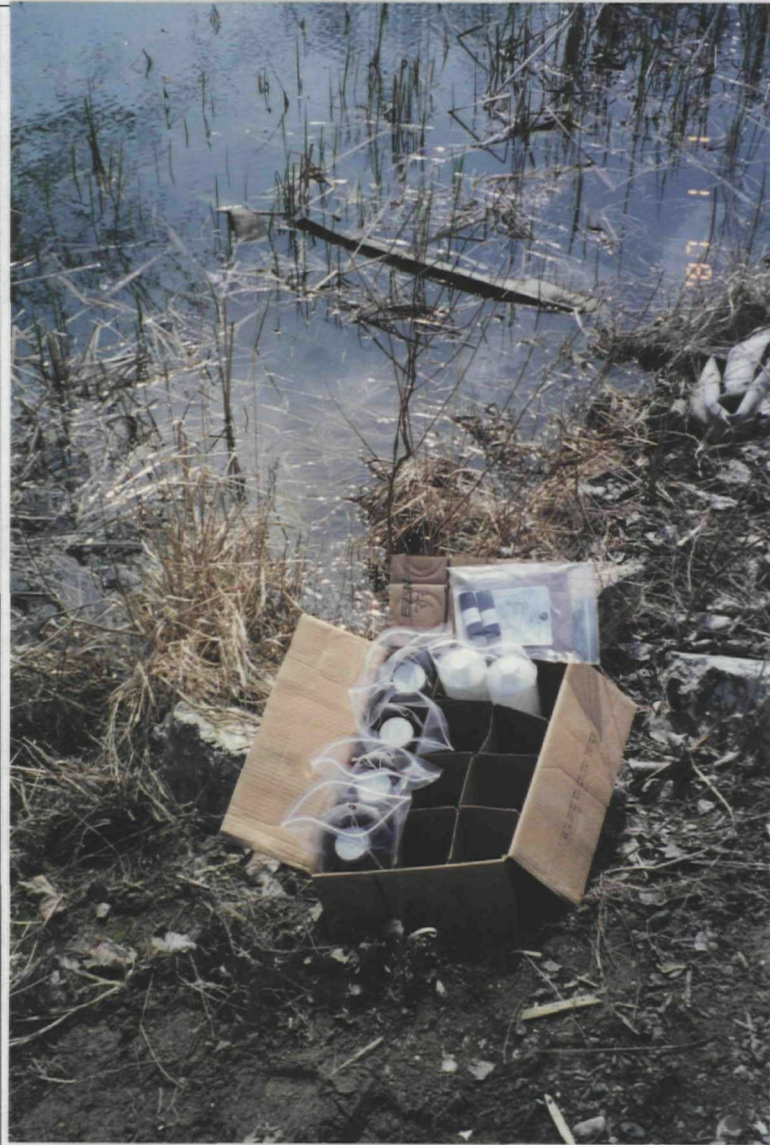
Photo No: 21
Sample No. SW-77
Date: April 11, 1995
Orientation: Southeast
Description: The Baghouse Pond surface water sample.

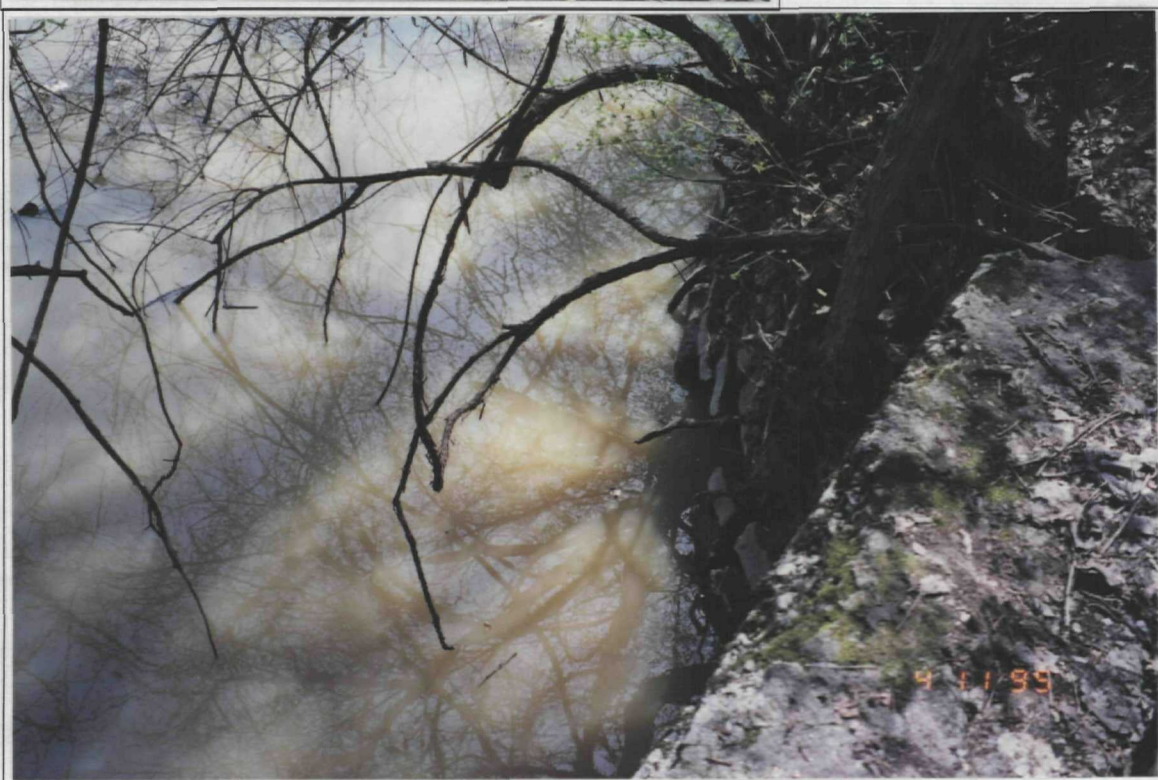
Photo No: 22
Sample No: SW-83, SE-74
Date: April 11, 1995
Orientation: -
Description: The American Ditch outfall into Alum Creek.

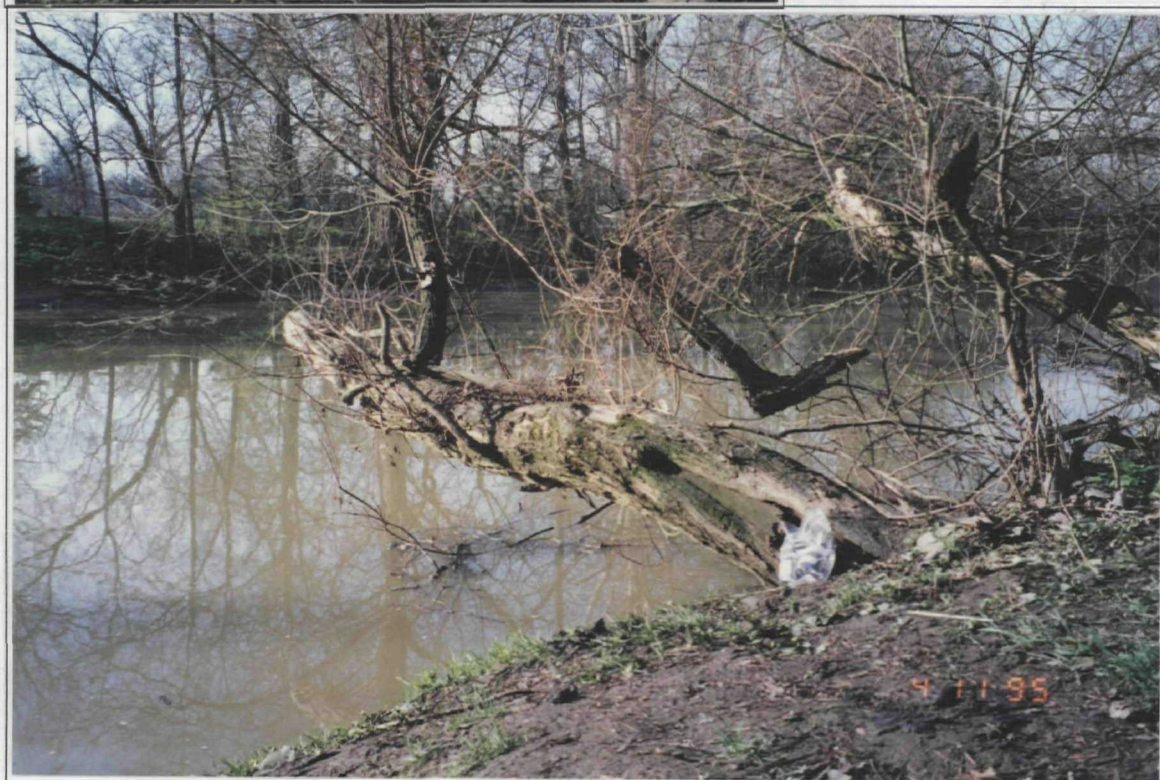
Photo No: 24
Sample No: SE-73
Date: April 11, 1995
Orientation: East
Description: The downstream Alum Creek sediment sample.
